(HTD-TR-00108) Structure Evaluation for Flood Barrier, Part 3

Date: 29 Dec 2013
Issue: 1

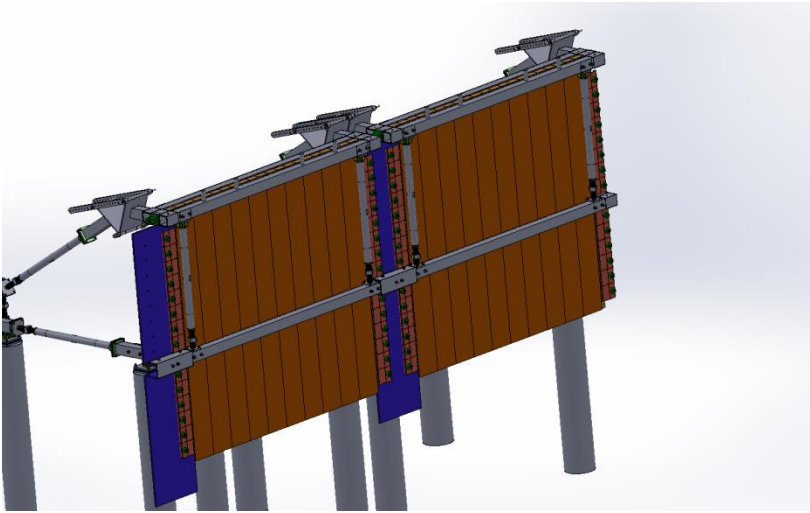
This report is a study to determine the structure integrity of 3.0m height x 3.0m width flood barrier, see Figures 1. The objective is to determine the stress, deflection, and factor of safety of critical assemblies in the design.

The barrier structure, as in part 1, will be divided into four separate critical assemblies as can be seen in Figure 1b. However in this report the whole metal structure and support legs will be evaluated against the weight of the concrete.
